H5A CORNER CAMERA

ANTI-LIGATURE & VANDAL-RESISTANT SOLUTION FOR HIGH-RISK ENVIRONMENTS

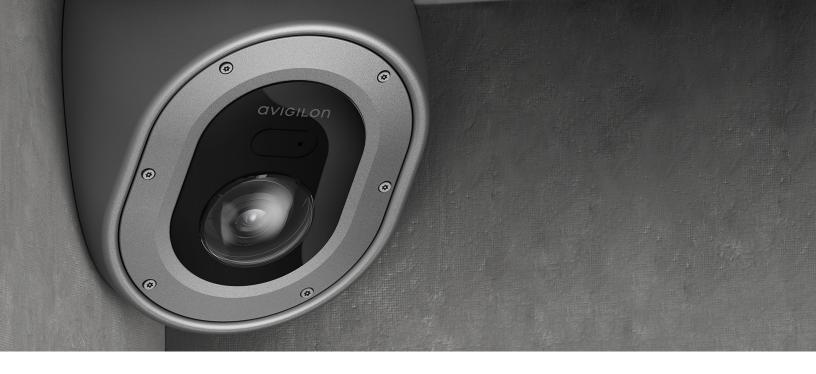
The Avigilon H5A Corner Camera is an anti-ligature and no-grip solution that is purpose-built to withstand the harshest attempts to destroy, detach, attach or disable it. Facilities seeking a vandal-resistant camera such as jails, prisons, hospitals or general applications (e.g. high schools) can leverage the camera's wide field of view and superior image quality for optimal situational awareness.
